Hindfoot alignment at one year after total knee arthroplasty

Takashi Takenaka¹ · Kazuya Ikoma¹ · Suzuyo Ohashi¹ · Yuji Arai¹ · Yusuke Hara¹ · Keiichiro Ueshima¹ · Koushiro Sawada¹ · Toshiharu Shirai¹ · Hiroyoshi Fujiwara¹ · Toshikazu Kubo¹

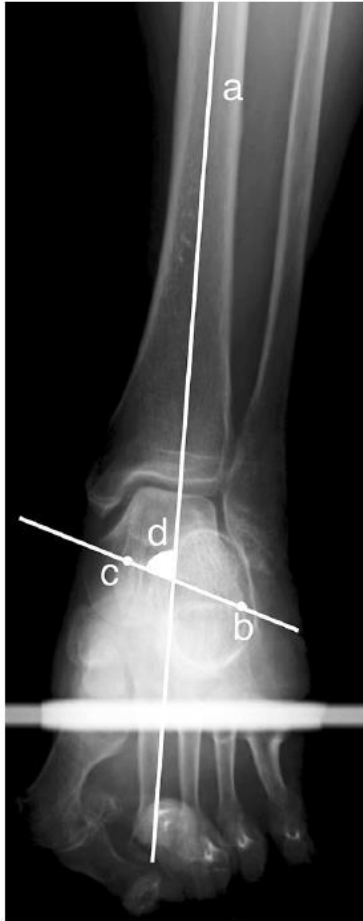
76度未満 : 後足部内反
76度以上 : 後足部外反

Fig. 1 Hindfoot radiograph image. *Line a* indicates the long axis of the tibia. *Point b* indicates the lateral extremity of the calcaneus at the posterior surface of the talocalcaneal joint. *Point c* indicates the superior margin of the sustentaculum tali. *Angle d* is the varus–valgus angle
